# Delaware River Chemical Spill & Impacts to Plant Operations

November 3, 2023

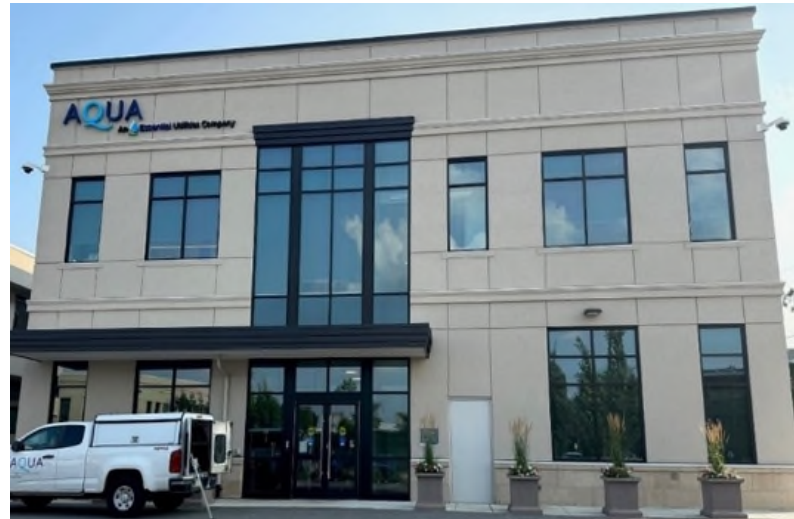
- Aqua's accredited environmental laboratory:
  - Certified in five states including PA and NJ for analysis of drinking water and wastewater
  - Runs 90,000 tests annually for compliance and operational sampling.
    - Utilizes instrumentation such as GC/MS, LC/MS & ICP-MS
- The laboratory employs a team of 20 chemists, microbiologists and quality assurance specialists
  - Operates 7-days a week
- Consists of three sections:
  - Microbiology
  - Inorganic Chemistry
  - Organic Chemistry

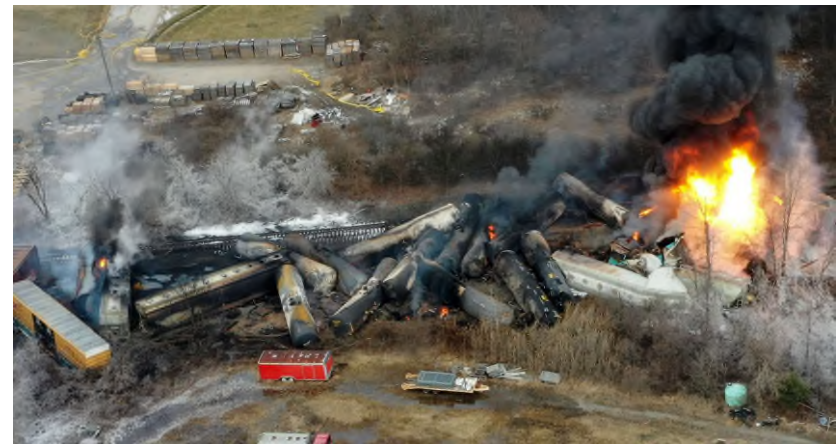
- February 3<sup>rd</sup>, 2023 – Norfolk Southern Train derailed
- Multiple chemicals listed on manifest
- Qualitative scans initially
- Quantitative: Operational method developed for several acrylate compounds
  - Butyl Acrylate
  - Ethyl Methacrylate
  - 2-Ethylhexyl acrylate
  - Methyl acrylate
