# Flat Rock Dam — Manayunk Canal Betterment Project

*Water Quality | Safety | Ecological Integrity*

**AWWA PA Section | Fall 2023 Joint Technical Conference**  
**Tuesday, October 24<sup>th</sup>, 2023 | 1:30 PM**

Construction Project Engineer for Flat Rock Dam

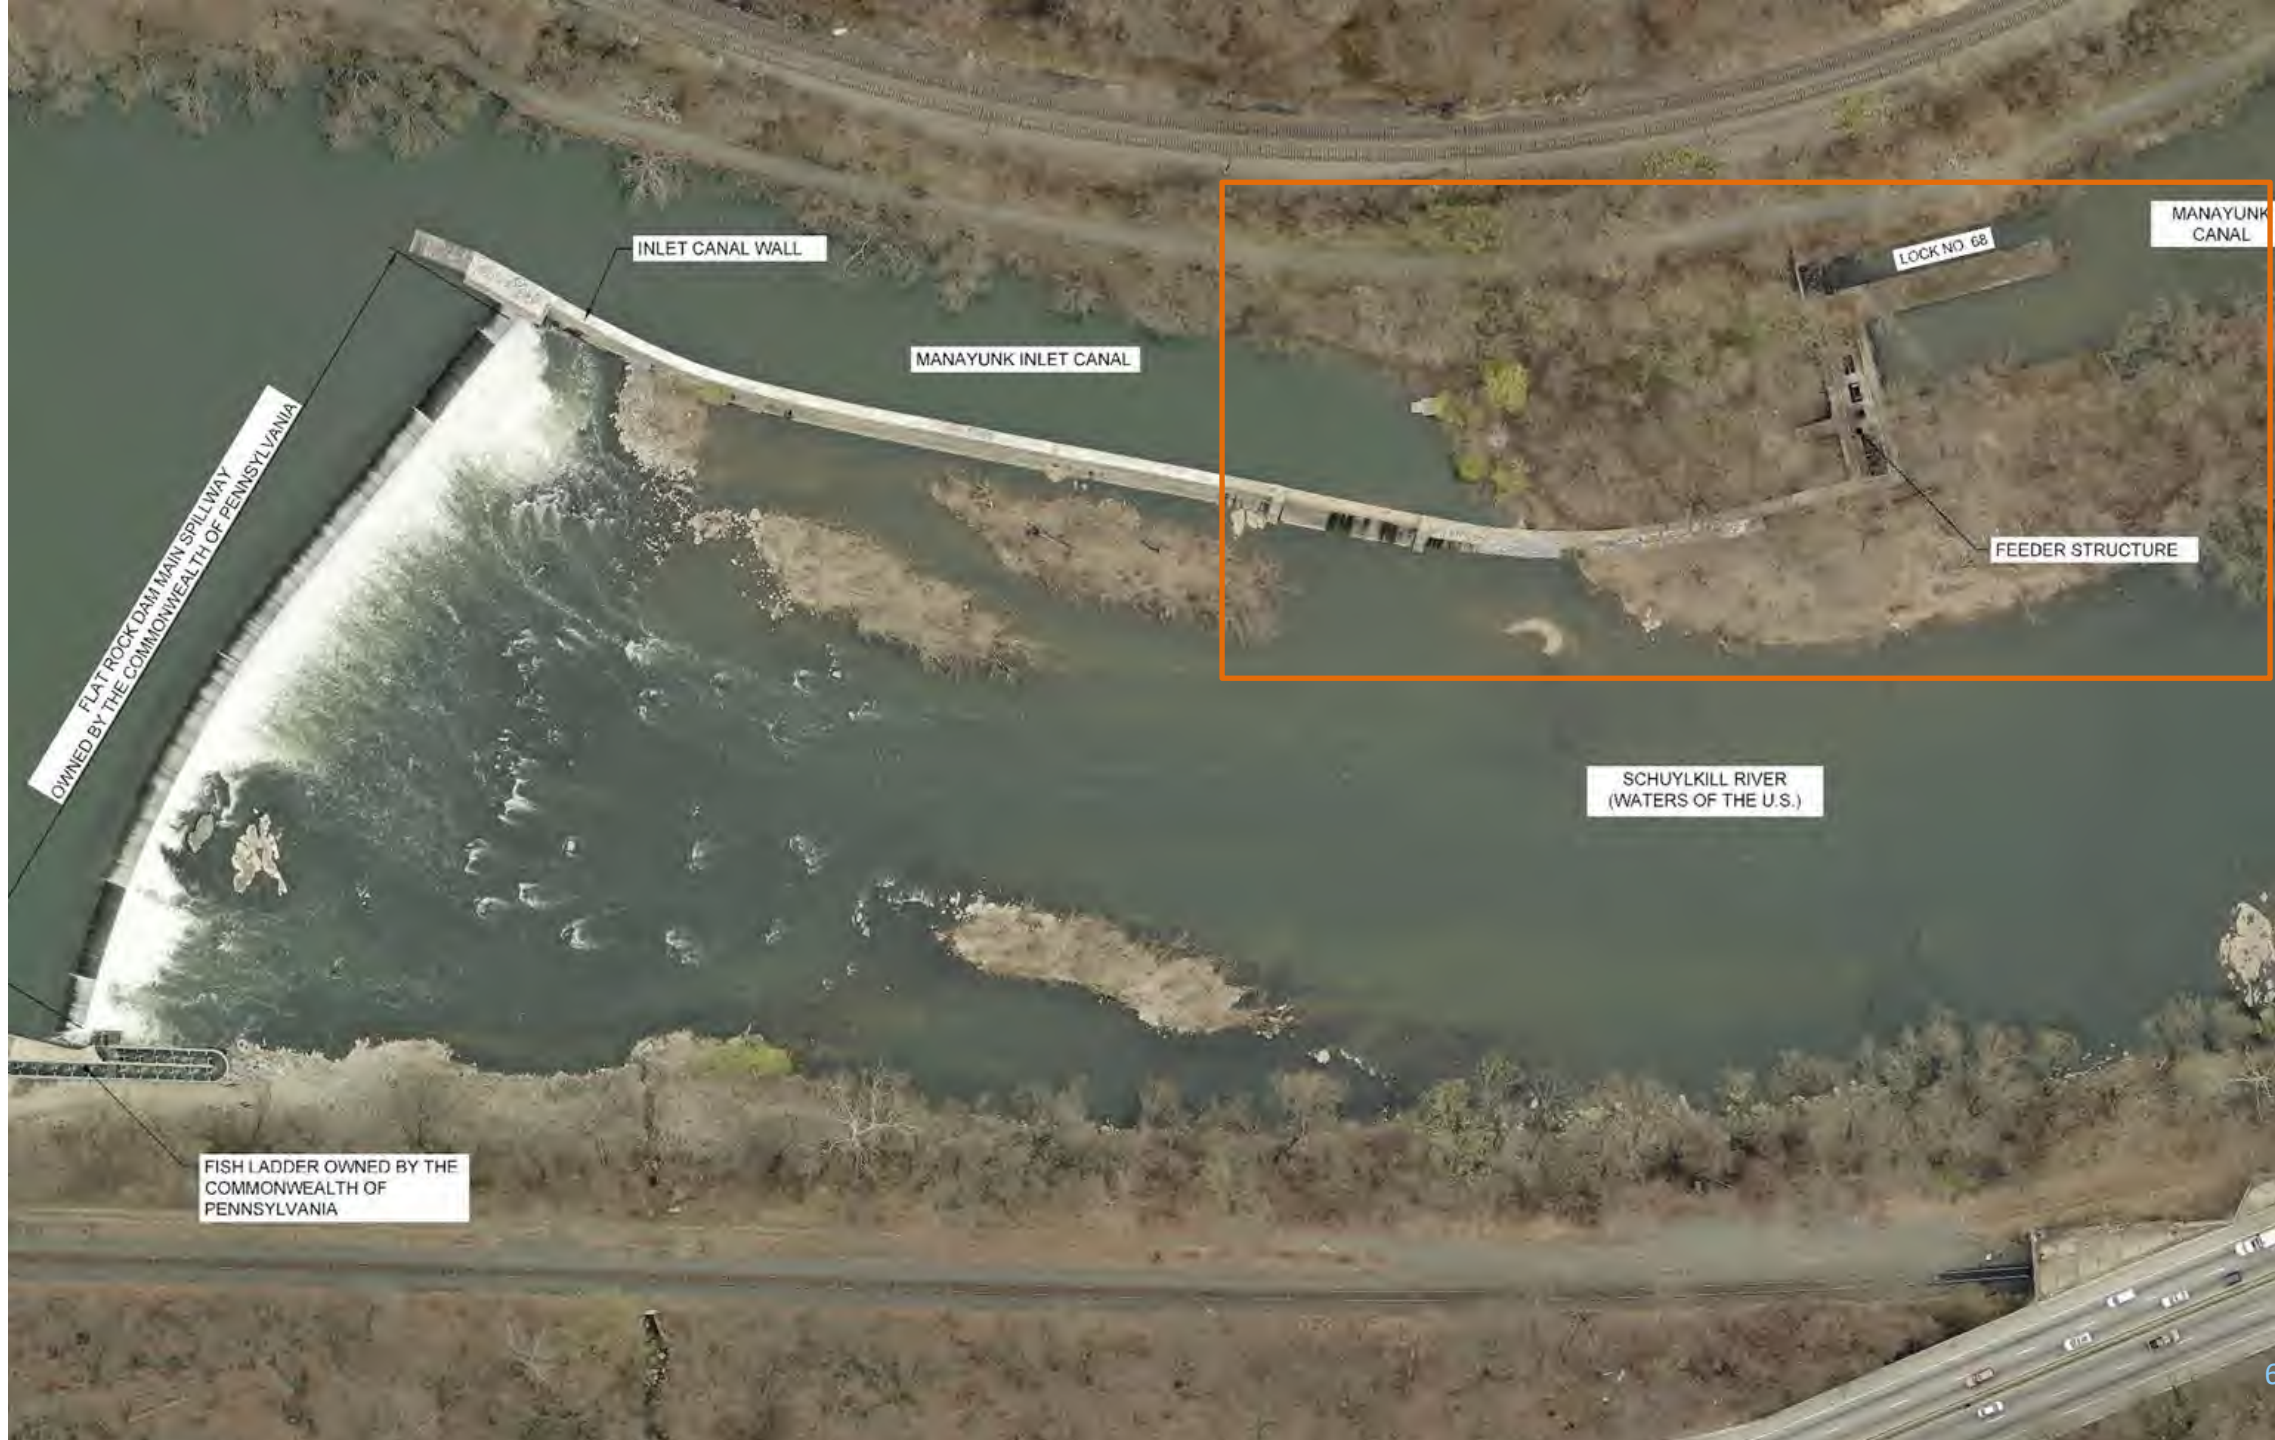
FLAT ROCK DAM MAIN SPILLWAY  
OWNED BY THE COMMONWEALTH OF PENNSYLVANIA

INLET CANAL WALL

MANAYUNK INLET CANAL

SCHUYLKILL RIVER  
(WATERS OF THE U.S.)

FISH LADDER OWNED BY THE  
COMMONWEALTH OF  
PENNSYLVANIA

MANAYUNK  
CANAL

LOCK NO 68

FEEDER STRUCTURE

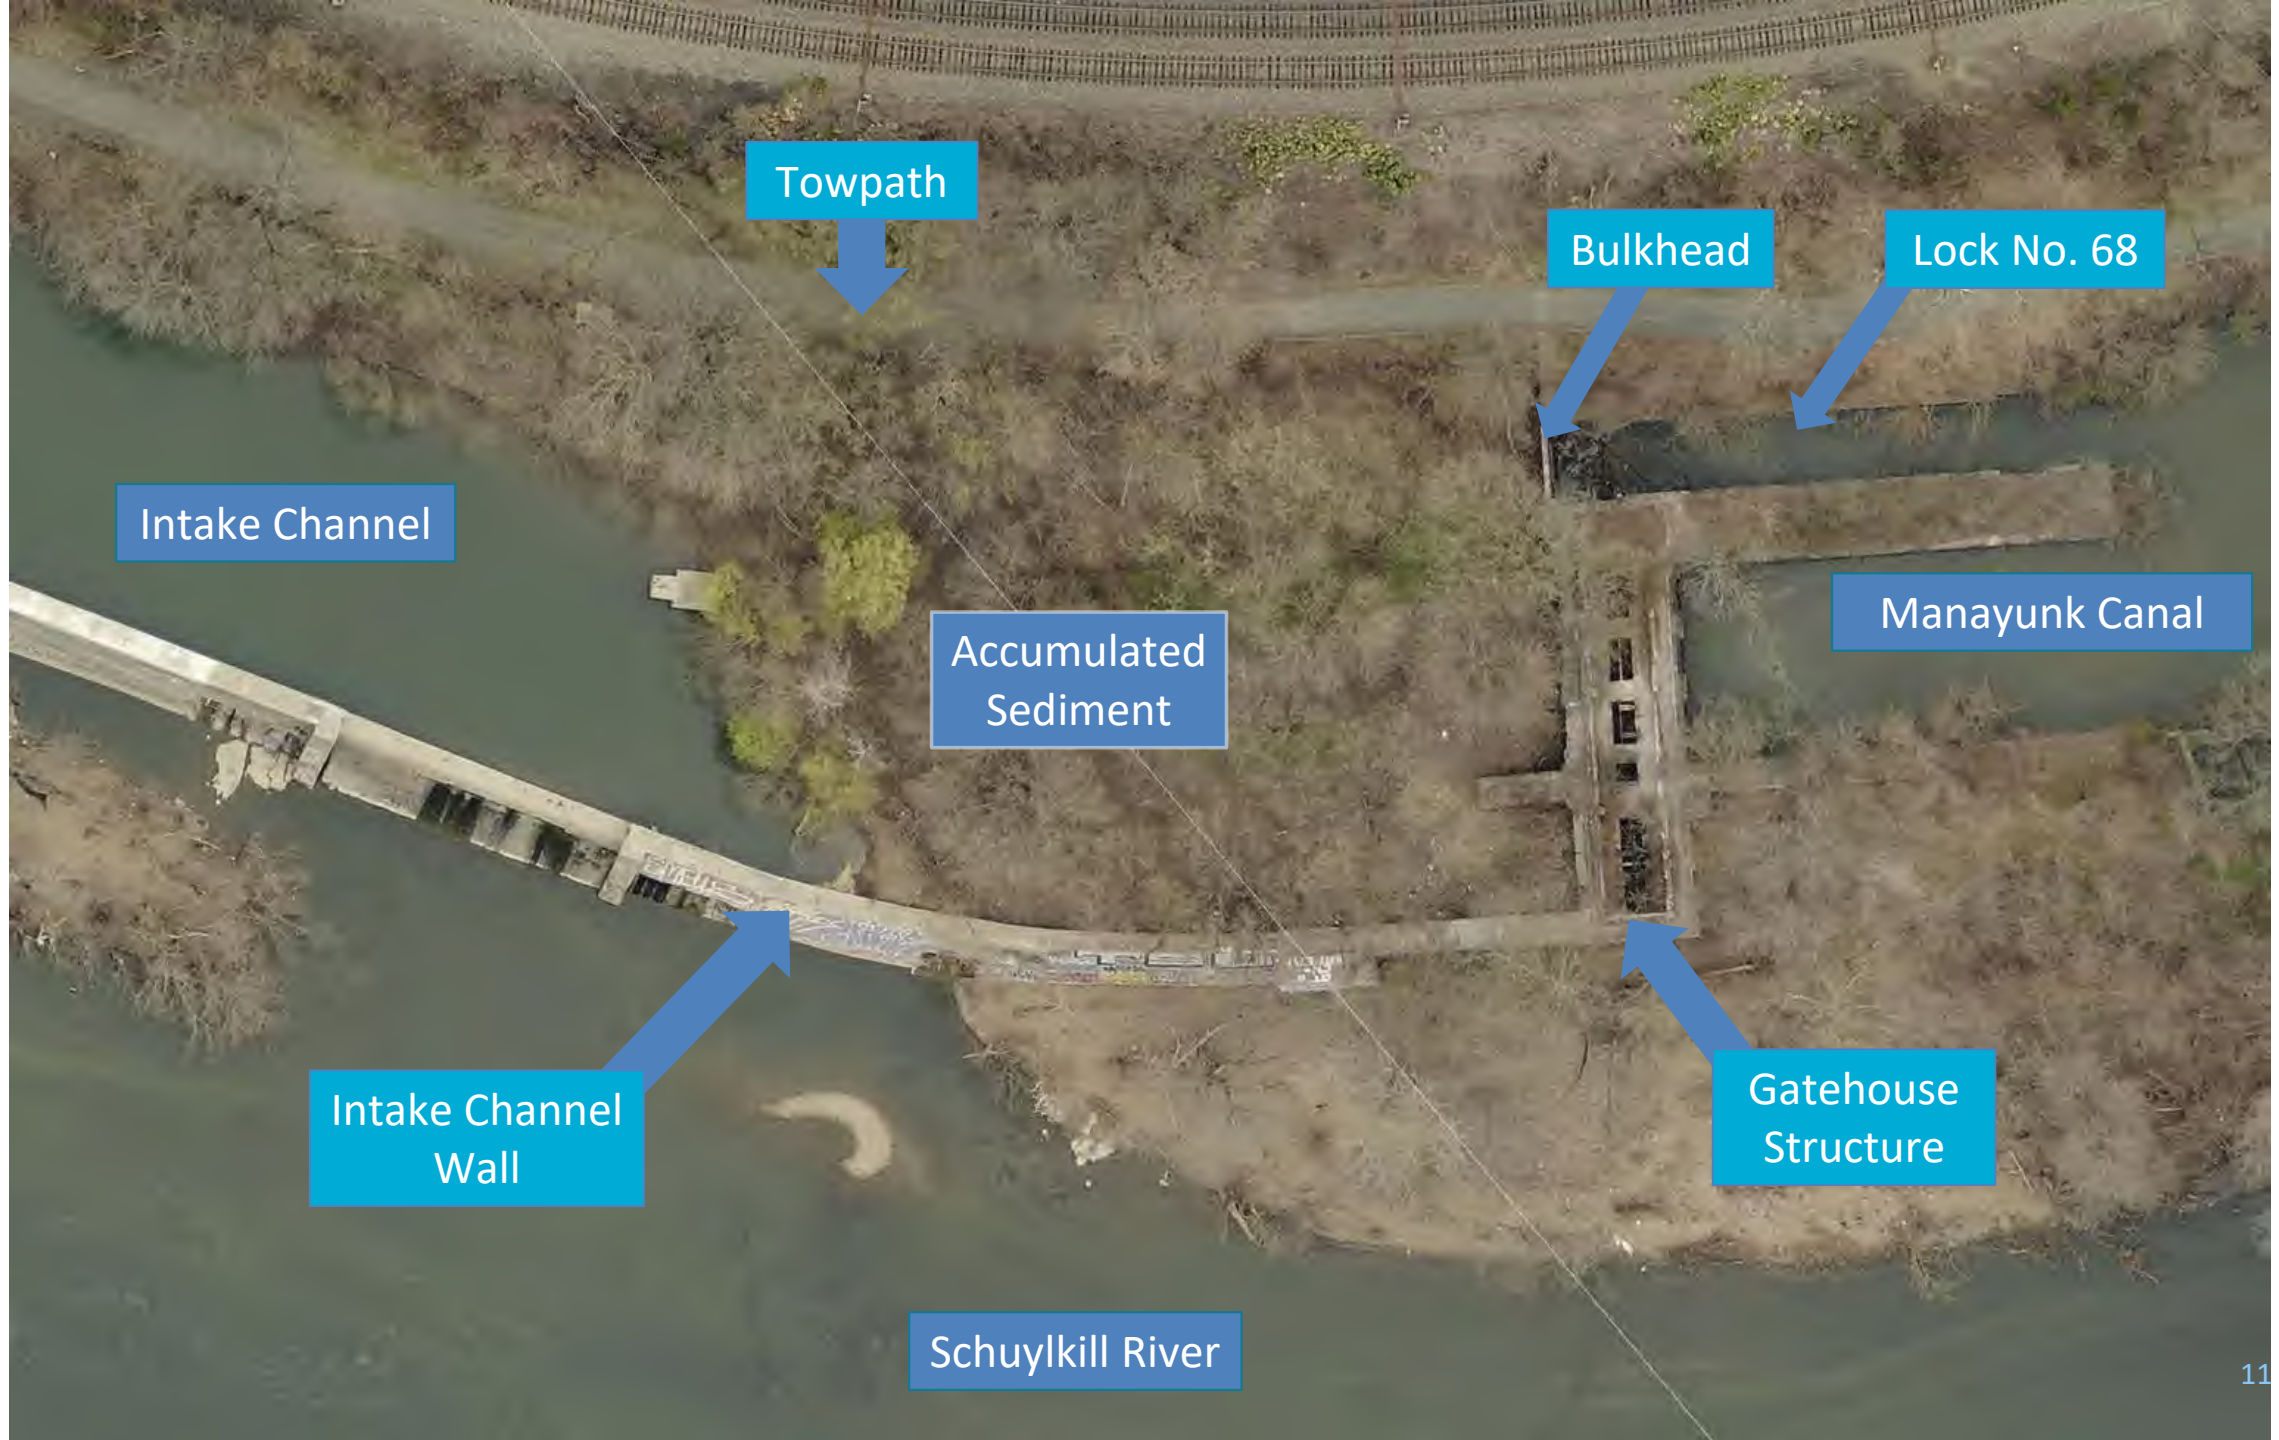
Towpath

Bulkhead

Lock No. 68

Intake Channel

Accumulated Sediment

Manayunk Canal

Intake Channel Wall

Gatehouse Structure

Schuylkill River

- Manayunk Canal has no connection to the Schuylkill River
- Canal is stagnant, leading to algae blooms and fish deaths
- Sediment, trash, and debris has accumulated upstream of the Gatehouse Structure
- Historic Gatehouse Structure has become unsafe
- Dam Repairs

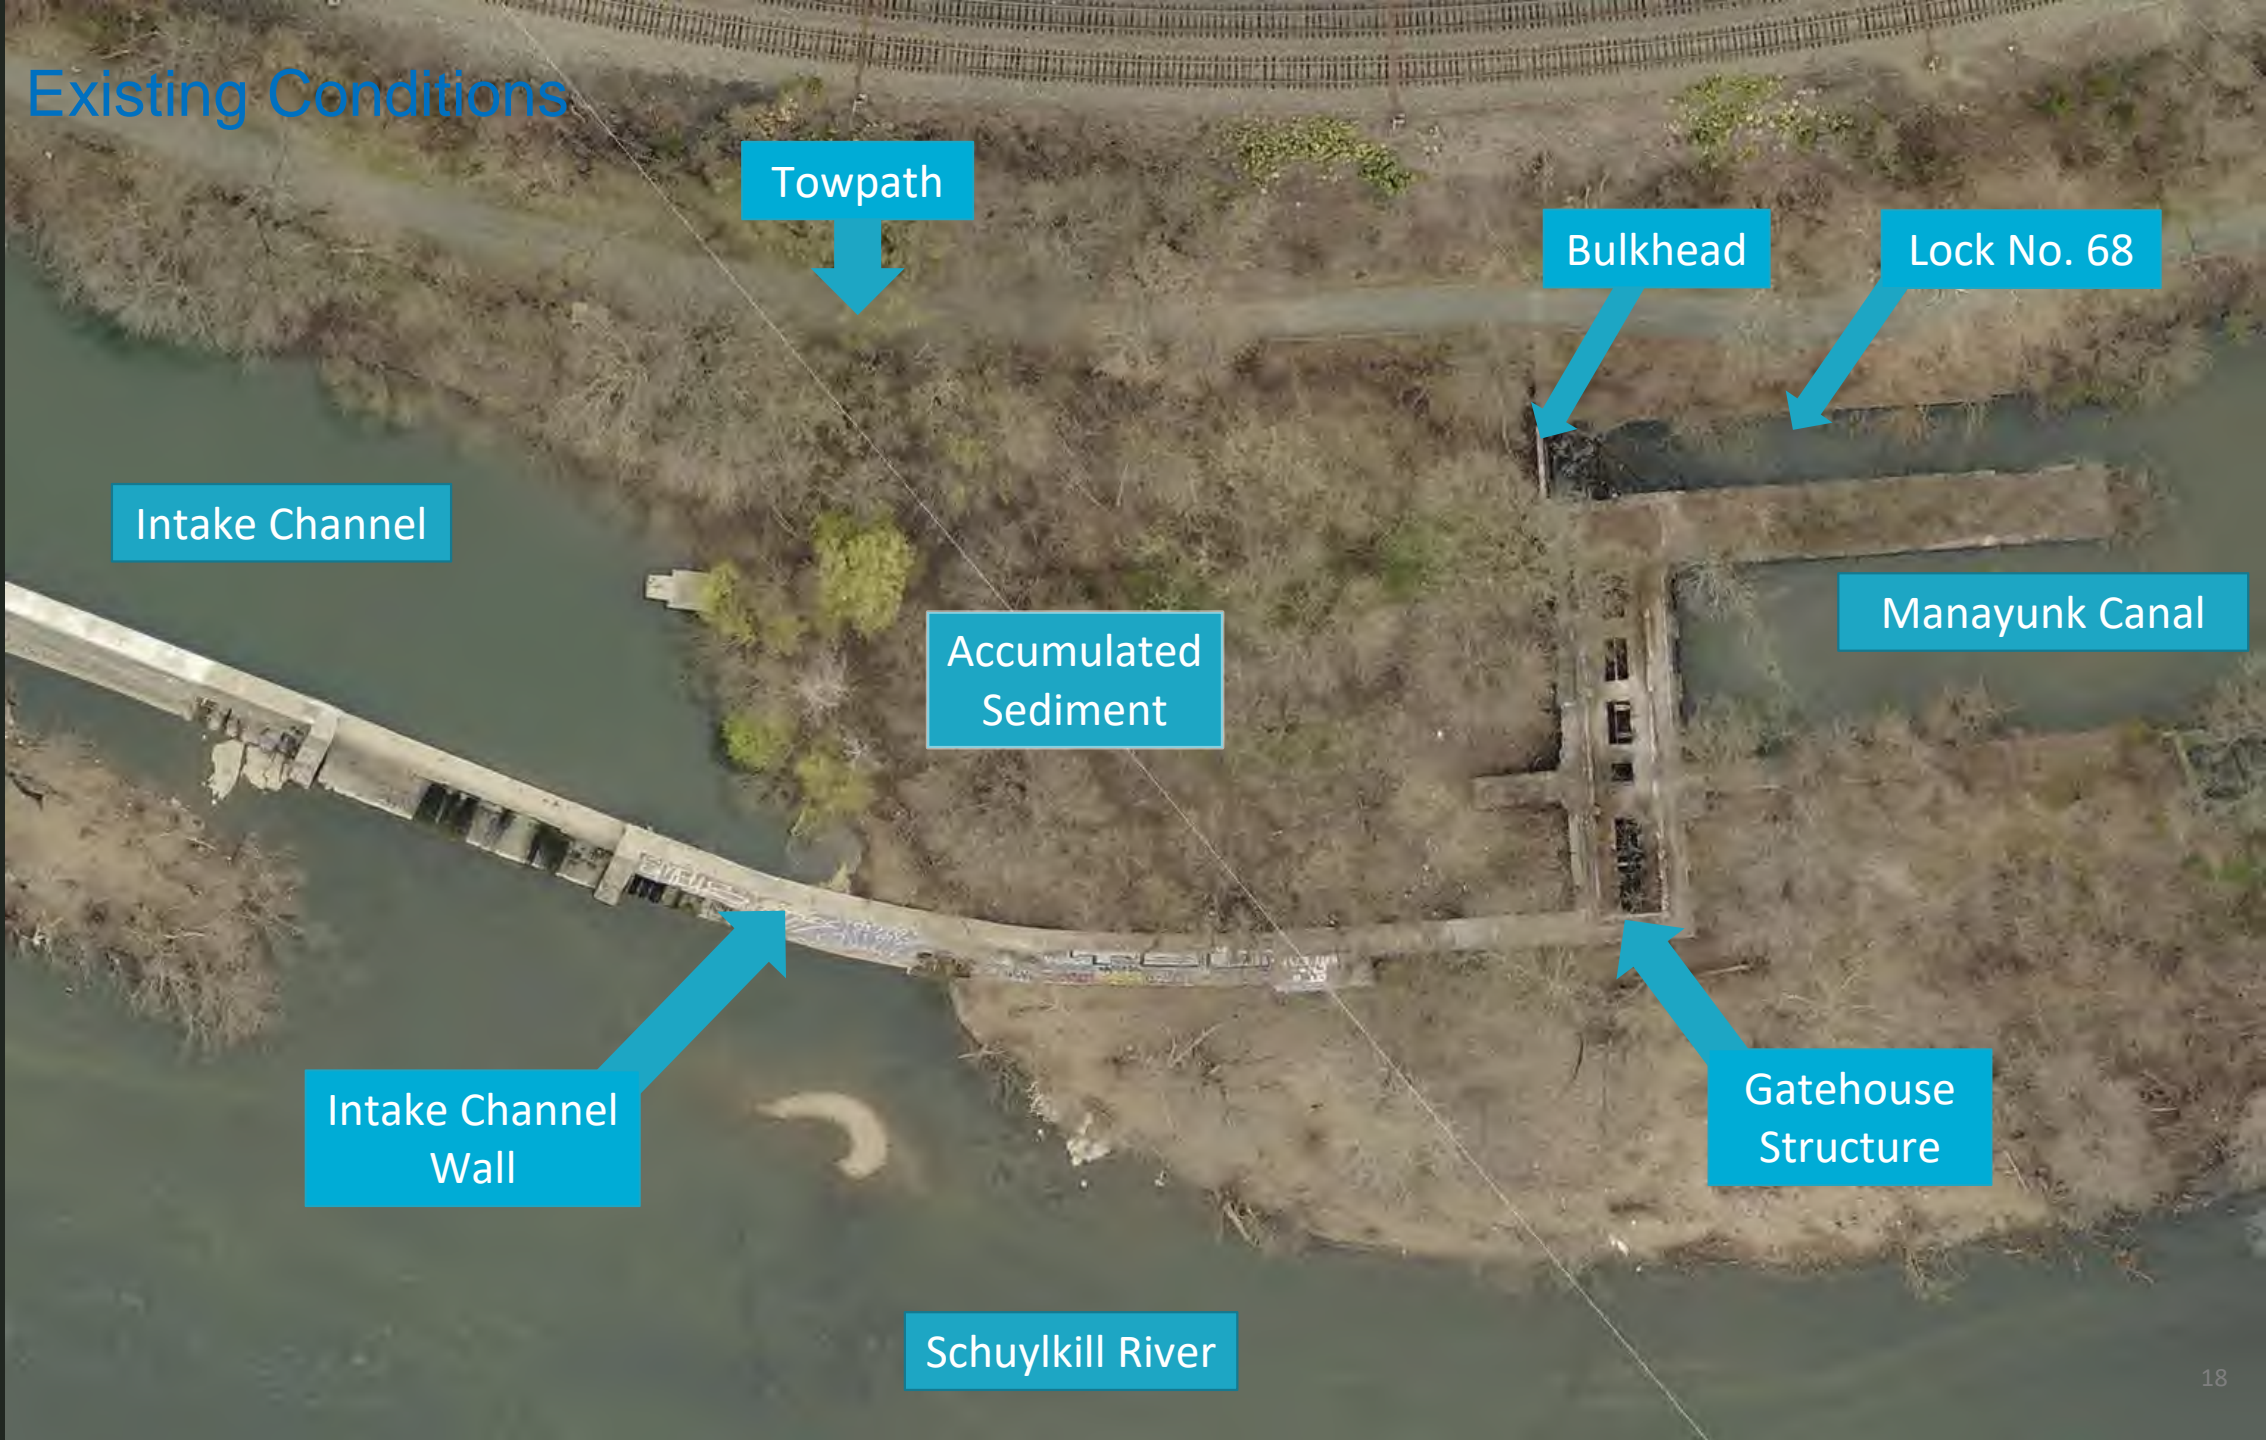
# Existing Conditions

Towpath

Bulkhead

Lock No. 68

Intake Channel

Accumulated Sediment

Manayunk Canal

Intake Channel Wall

Gatehouse Structure

Schuylkill River

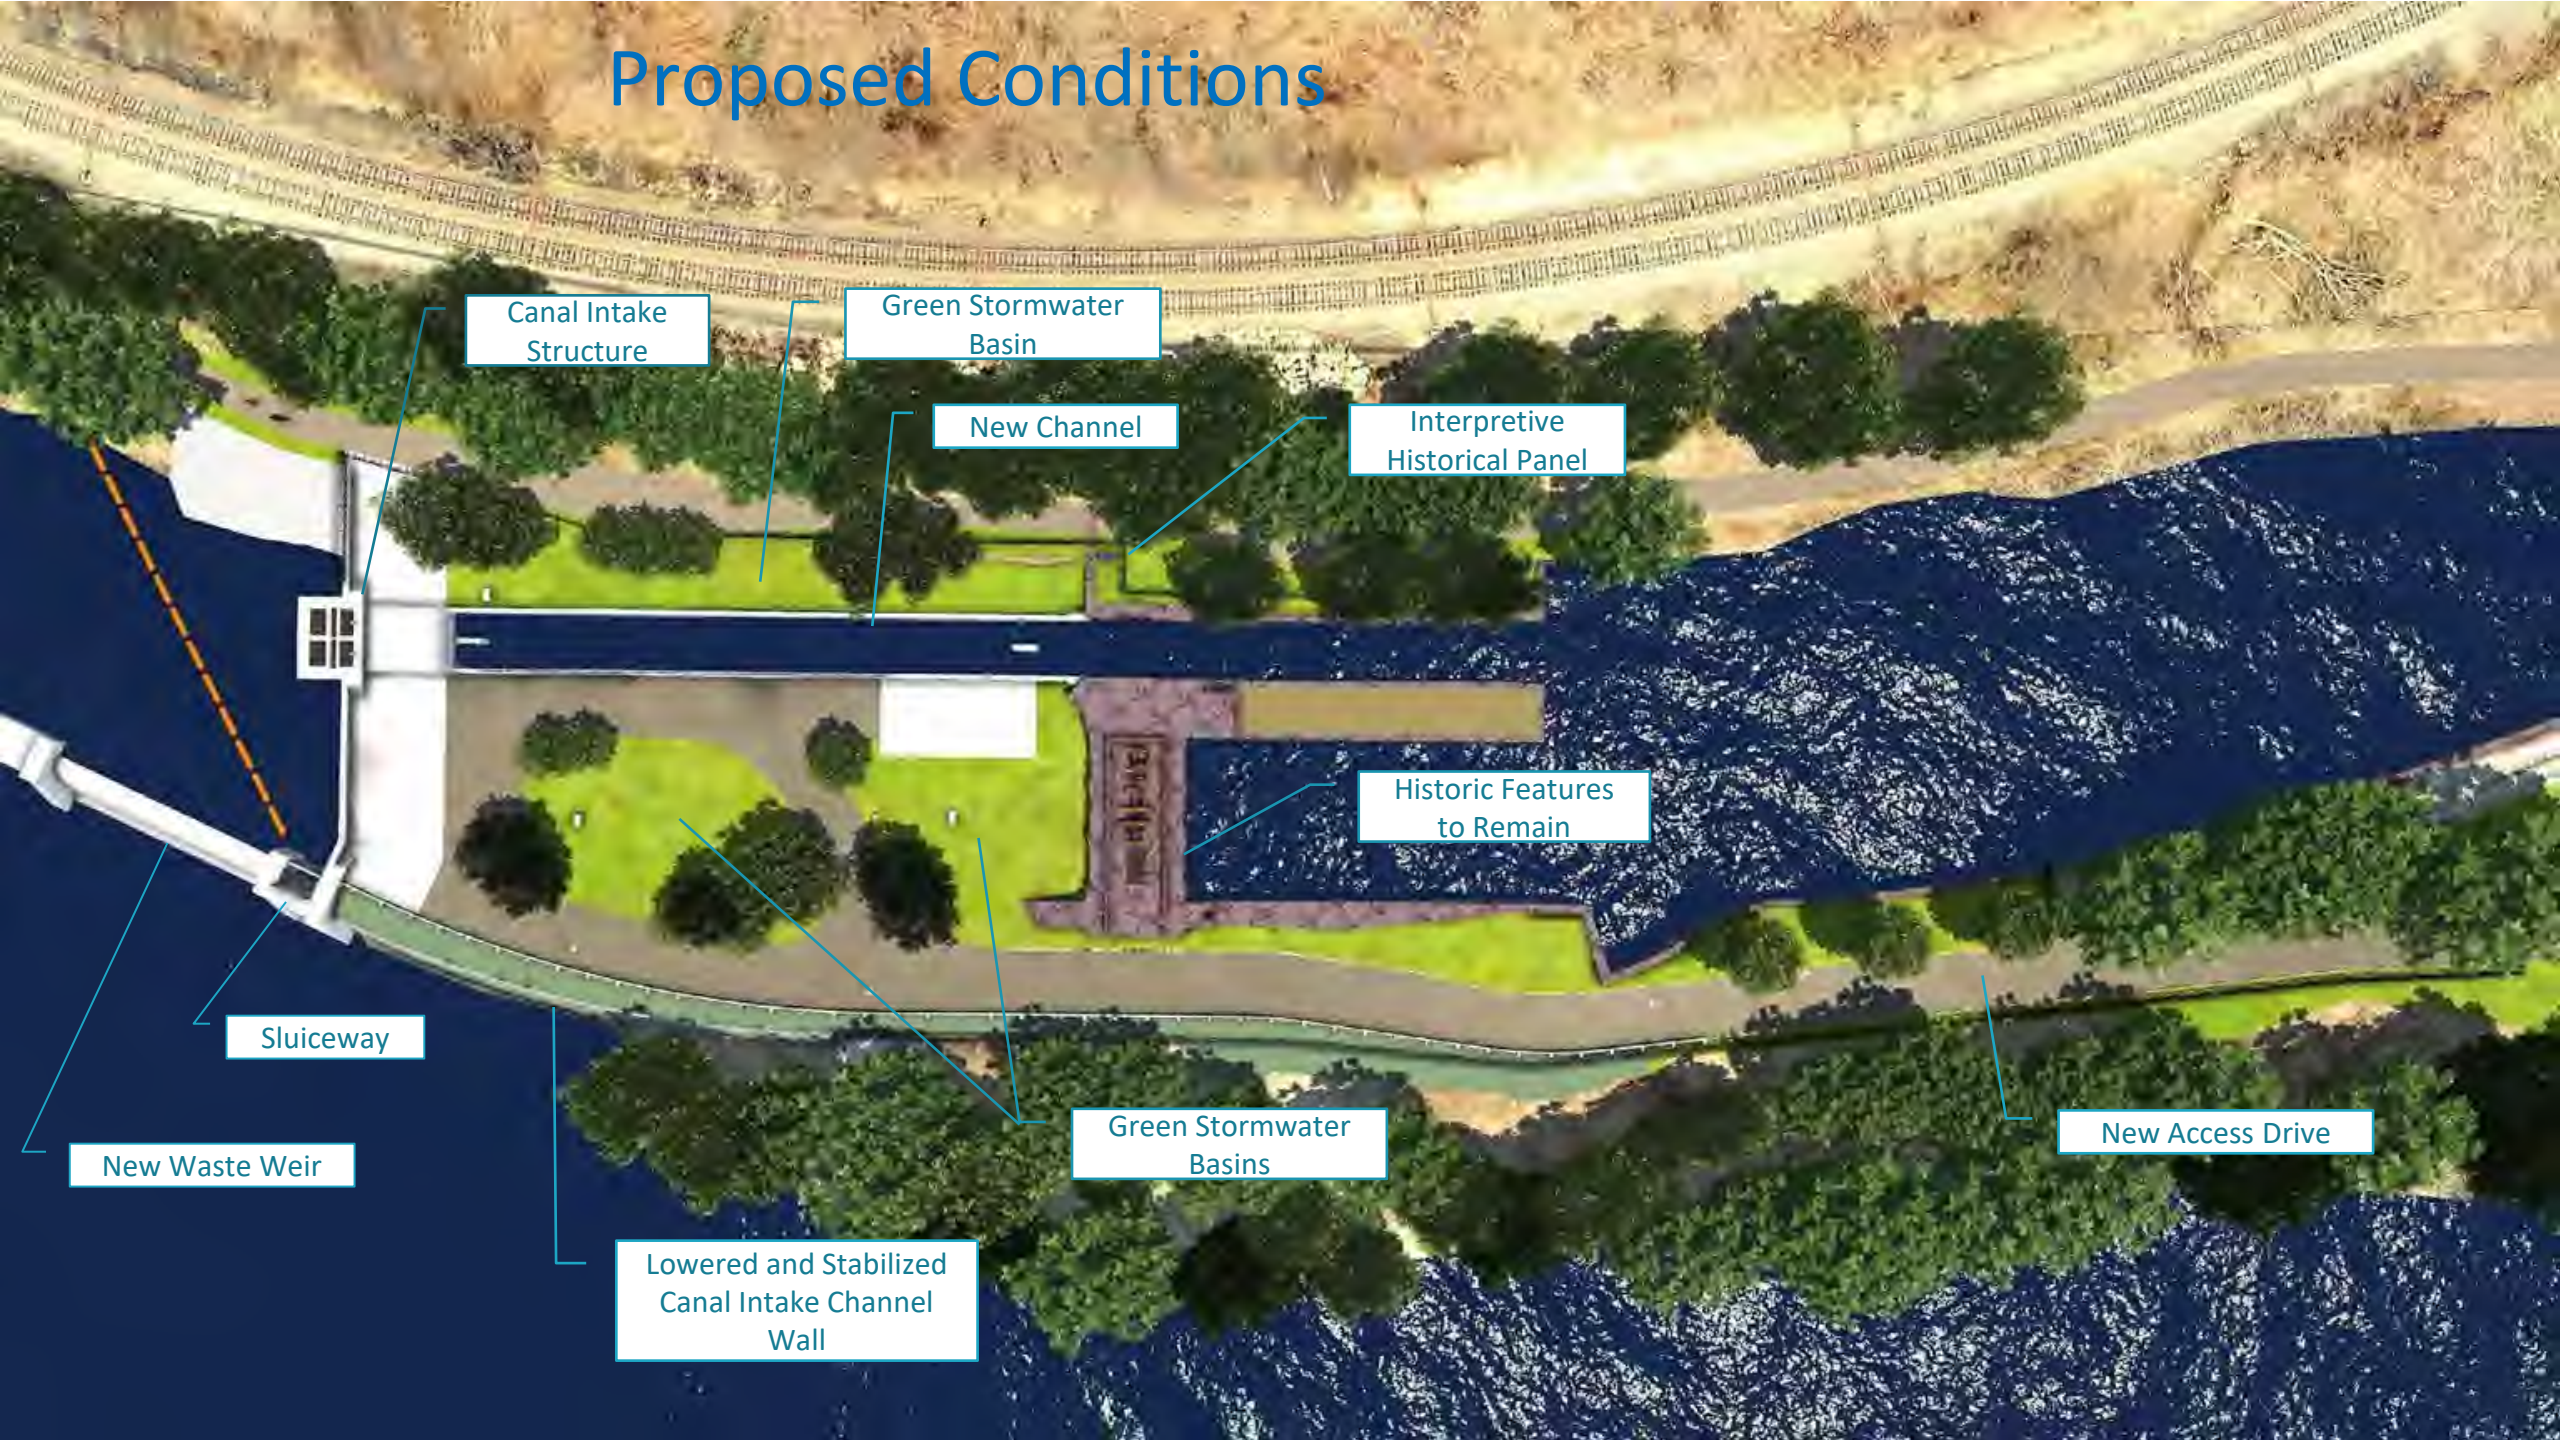
# Proposed Conditions

Canal Intake Structure

Green Stormwater Basin

New Channel

Interpretive Historical Panel

Historic Features to Remain

Sluiceway

New Waste Weir

Green Stormwater Basins

New Access Drive

Lowered and Stabilized Canal Intake Channel Wall

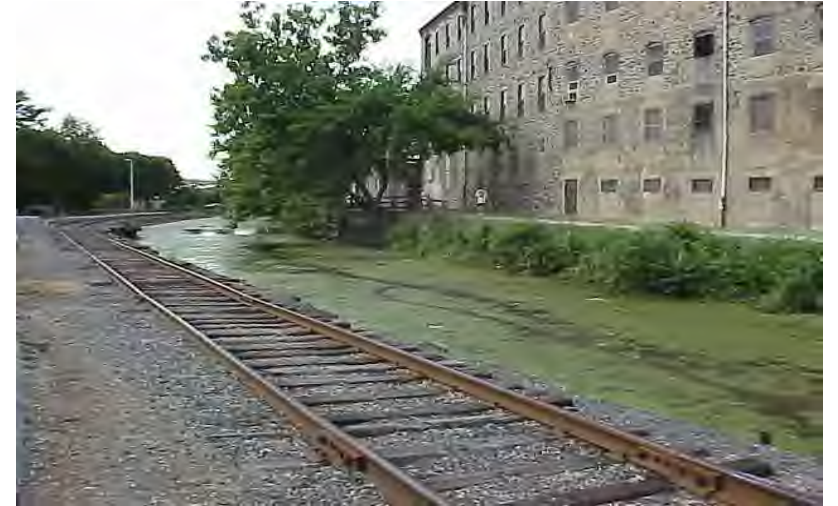
Algal bloom during drought conditions in 1999  
(Upstream view at Lock Street)

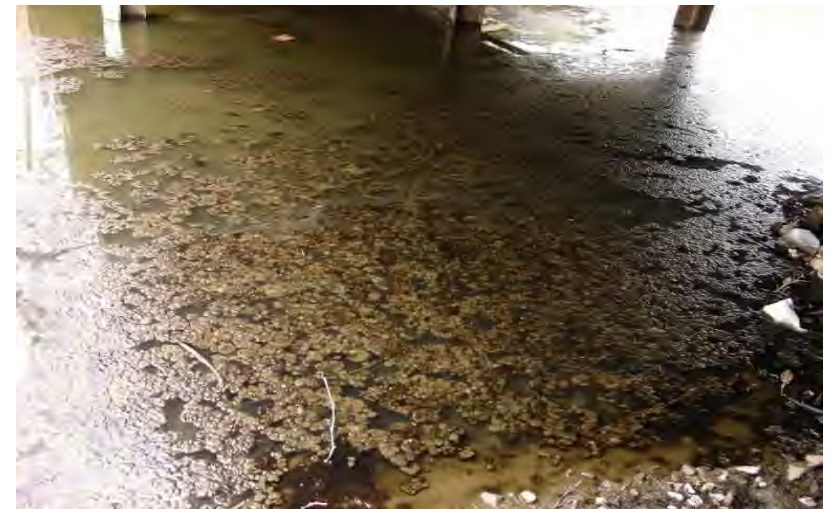
Floating mats of benthic algae at Lock Street bridge  
(2006)

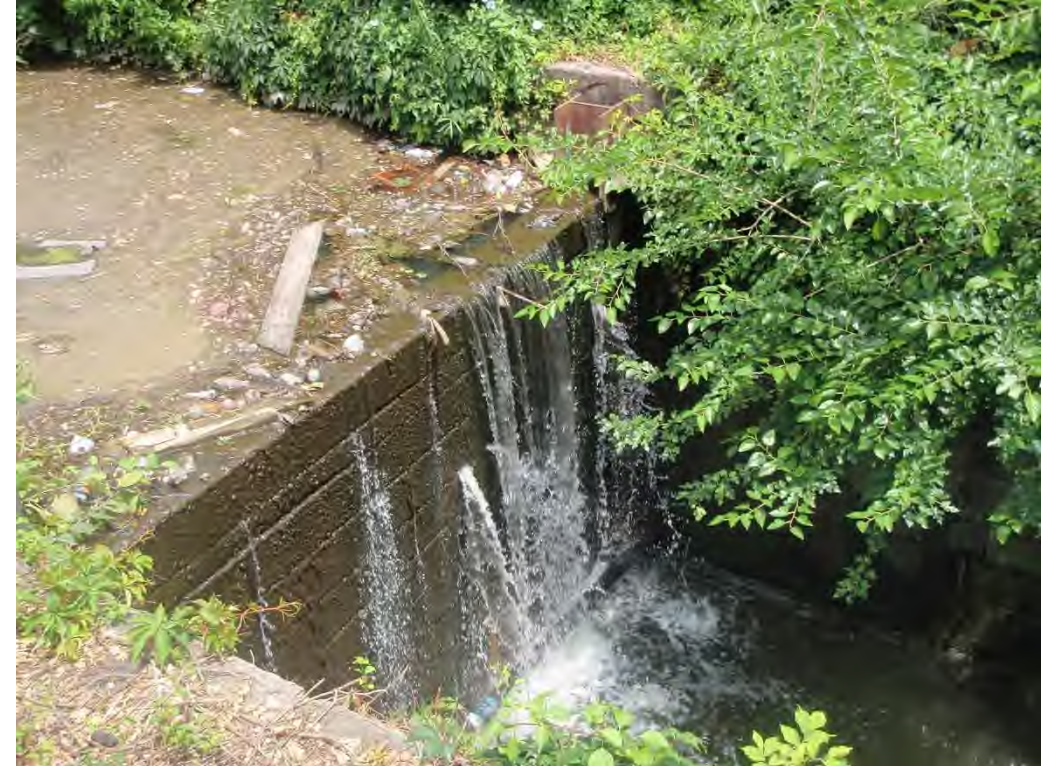
2011 summer flows over Lock Street (~1 cfs)

- **Present conditions:**
  - Spring flow ranges from 3 – 5 cfs
  - Summer flow ranges from 1 – 3 cfs
  - Average velocity of 0.03 ft/s
- **Post-construction conditions:**
  - Flow ranges between 50 – 110 cfs
  - Average velocity between 0.3 – 0.5 ft/s

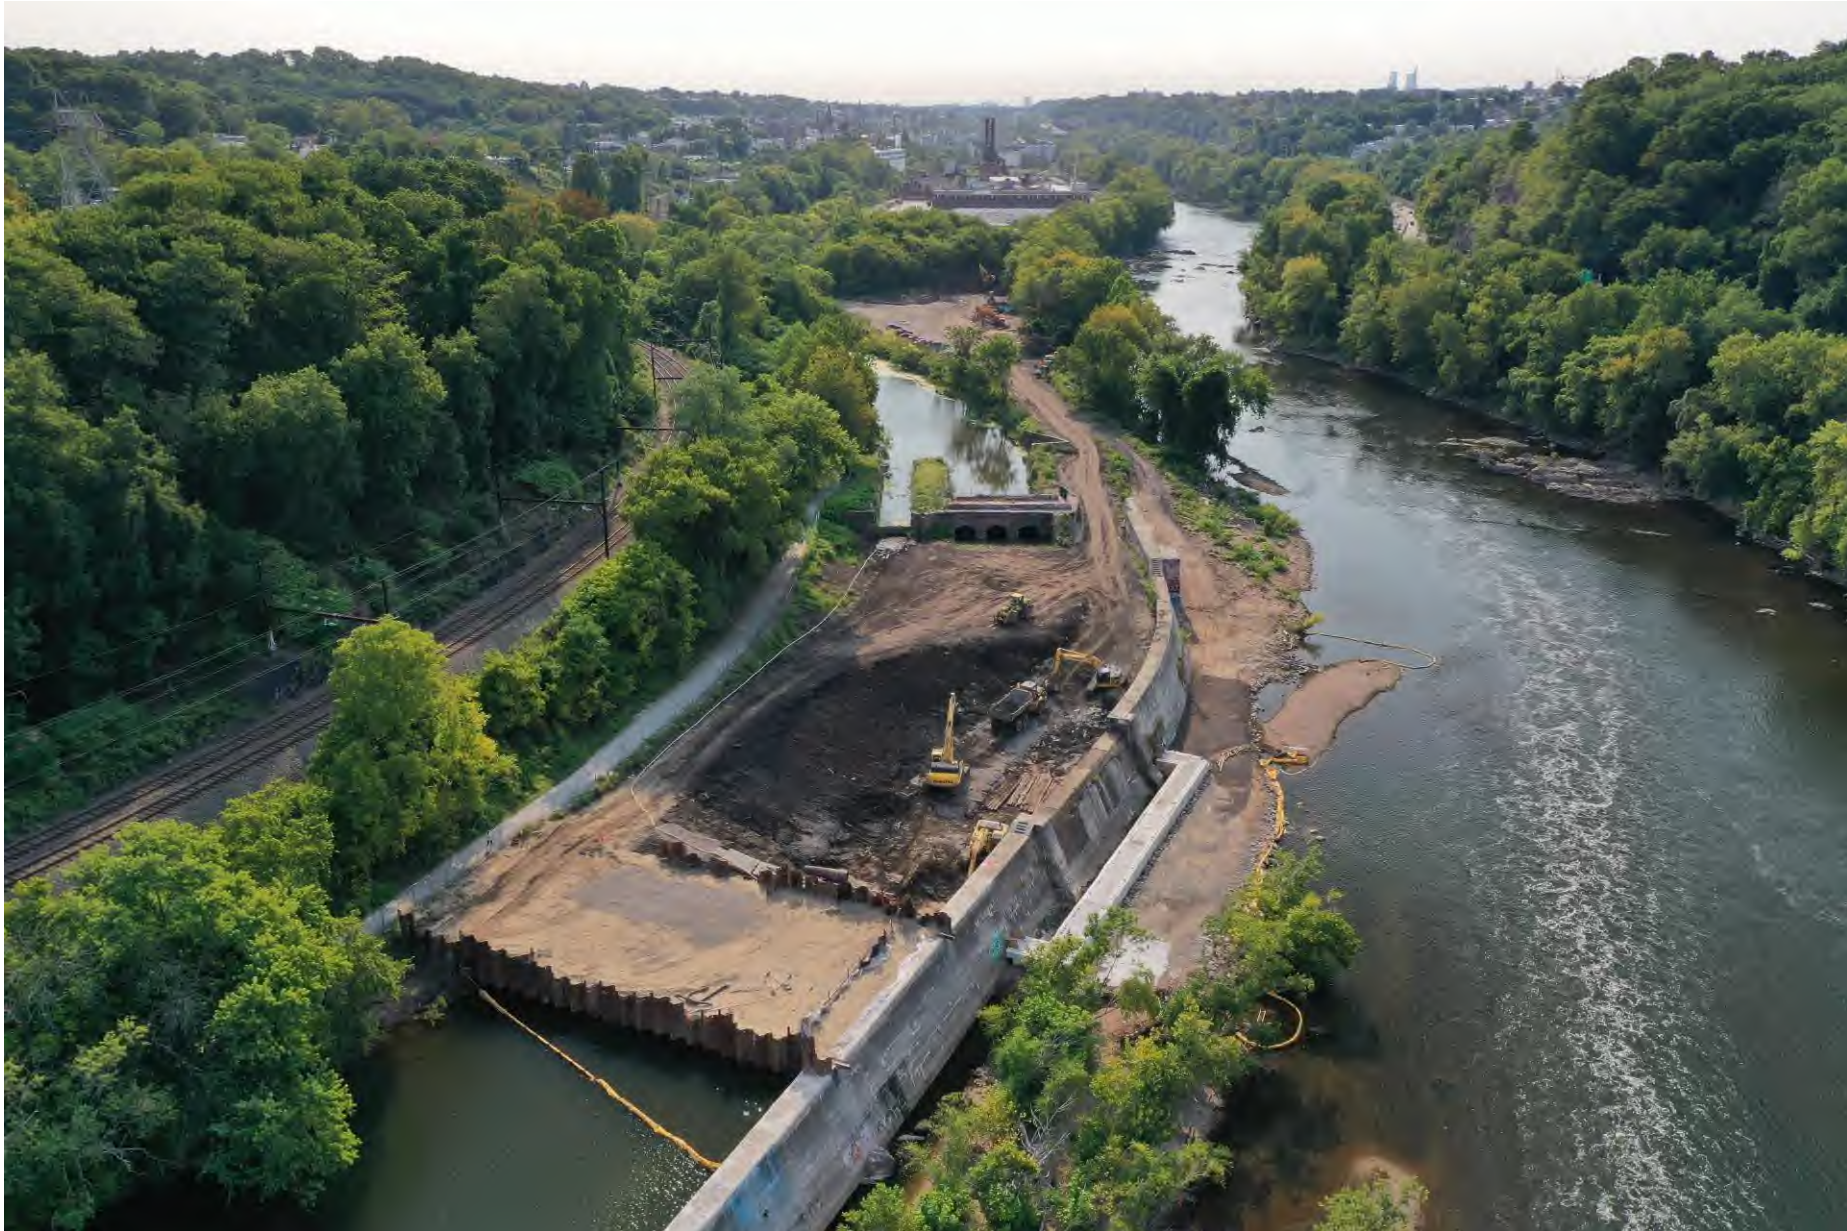
# October 2022 - Installation of Post-tensioned Rock Anchors

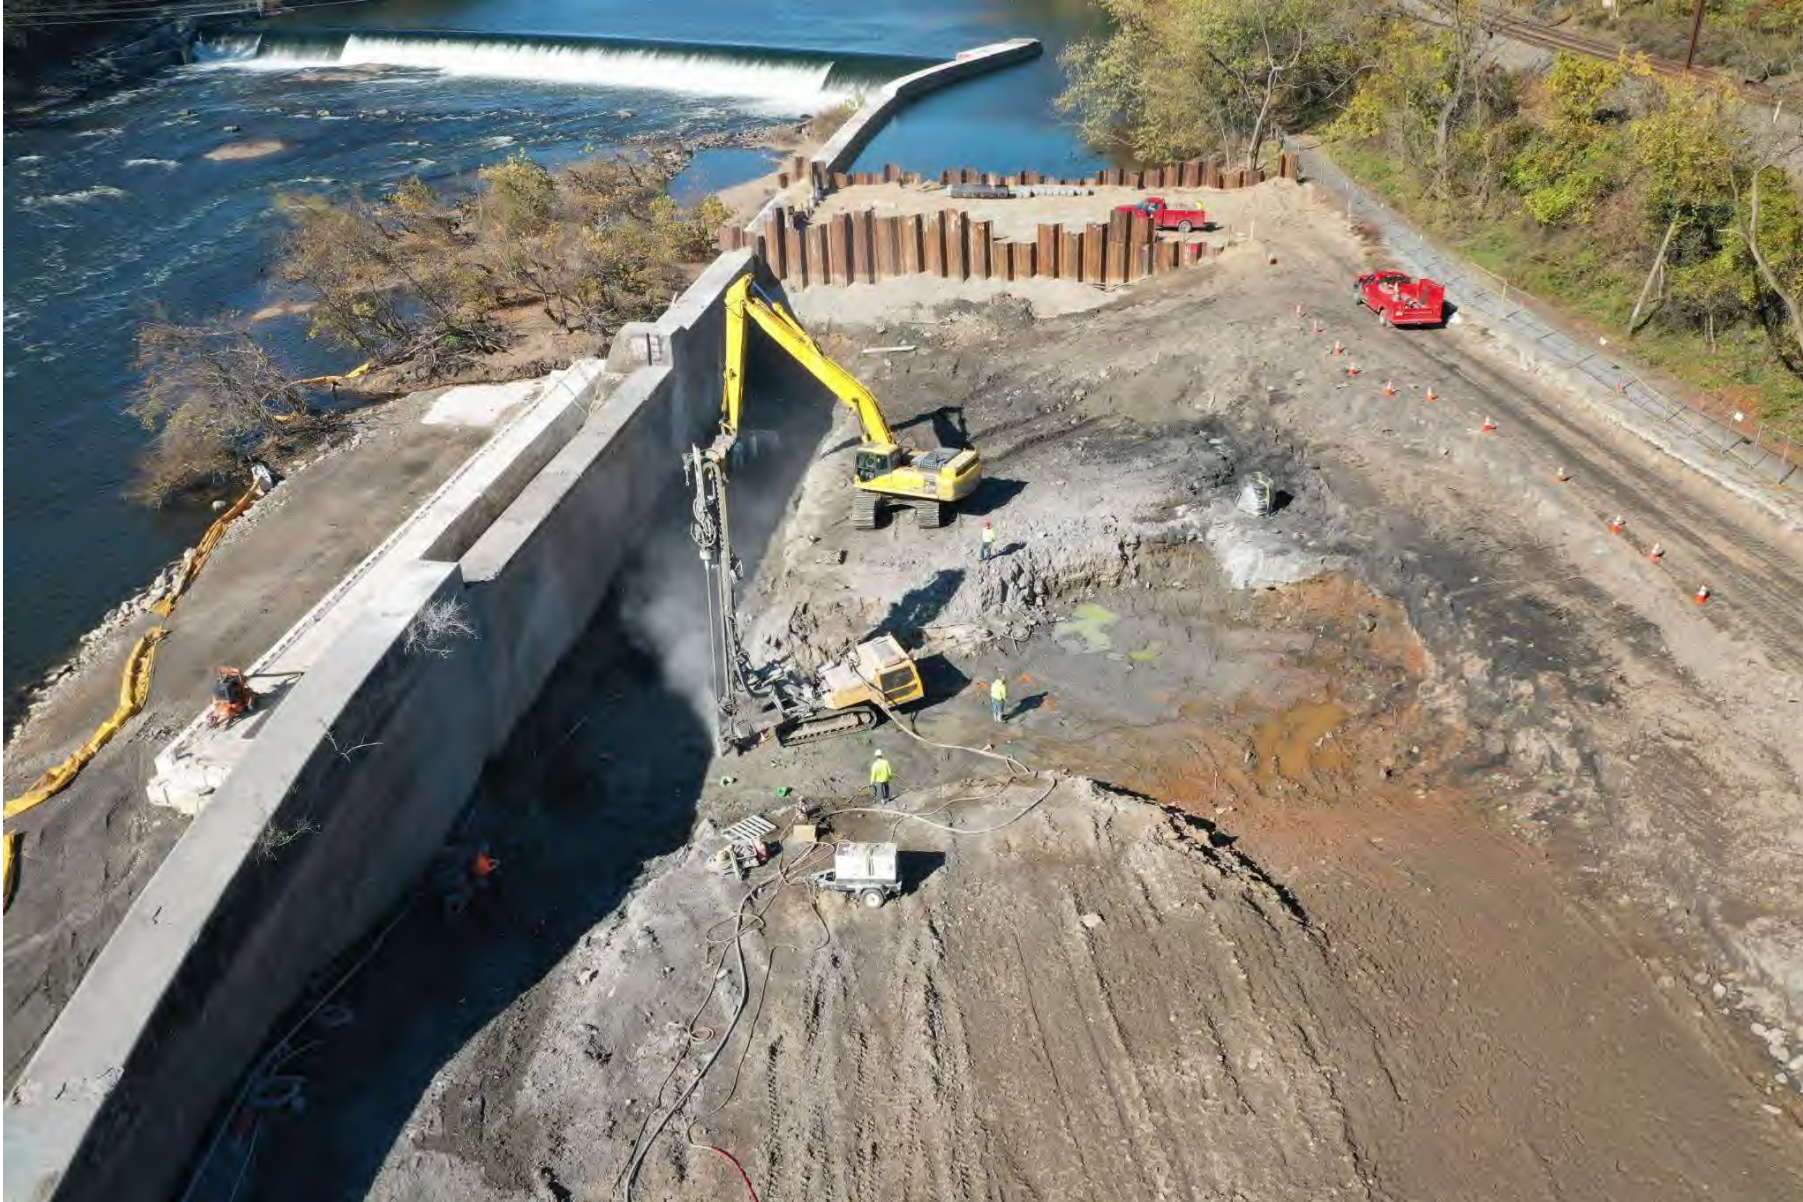
# October 2022 - Excavation and Anchors at Bulkhead Wall and Canal Intake

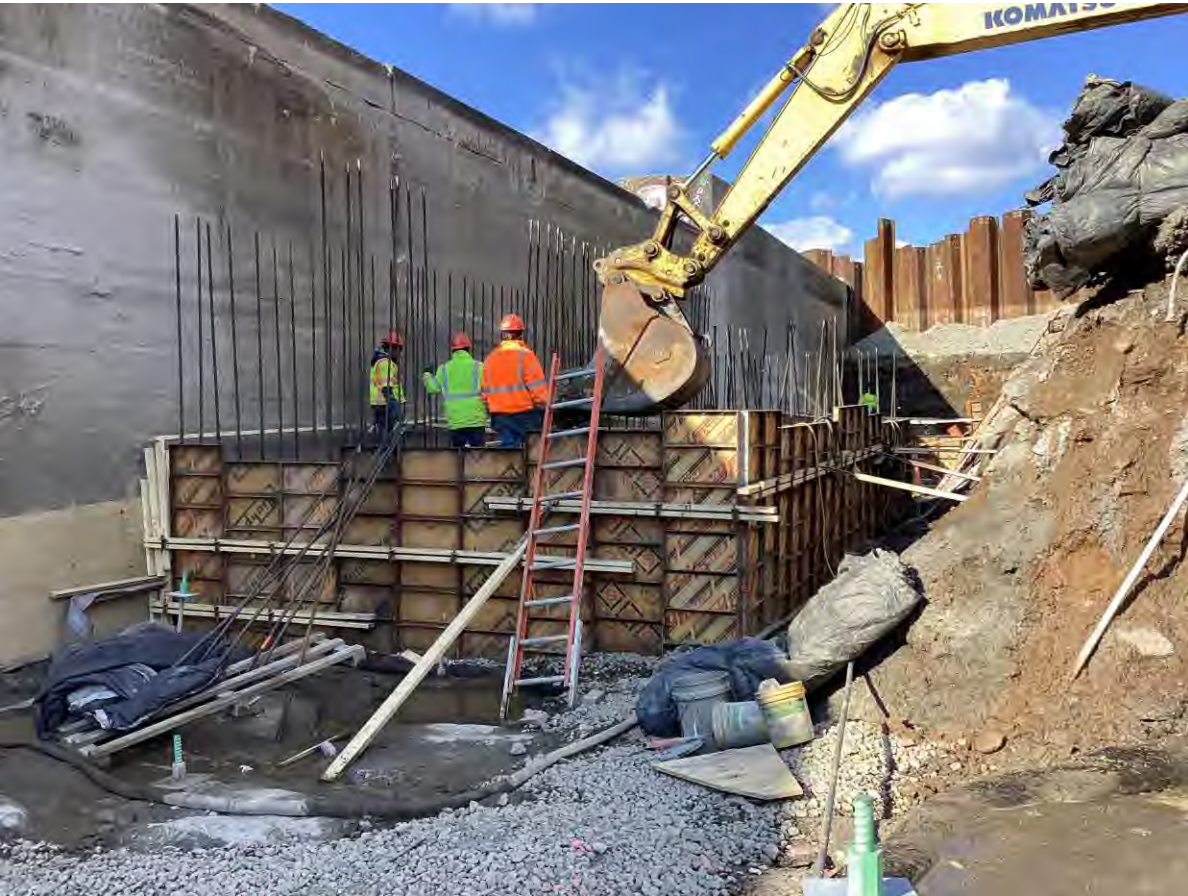
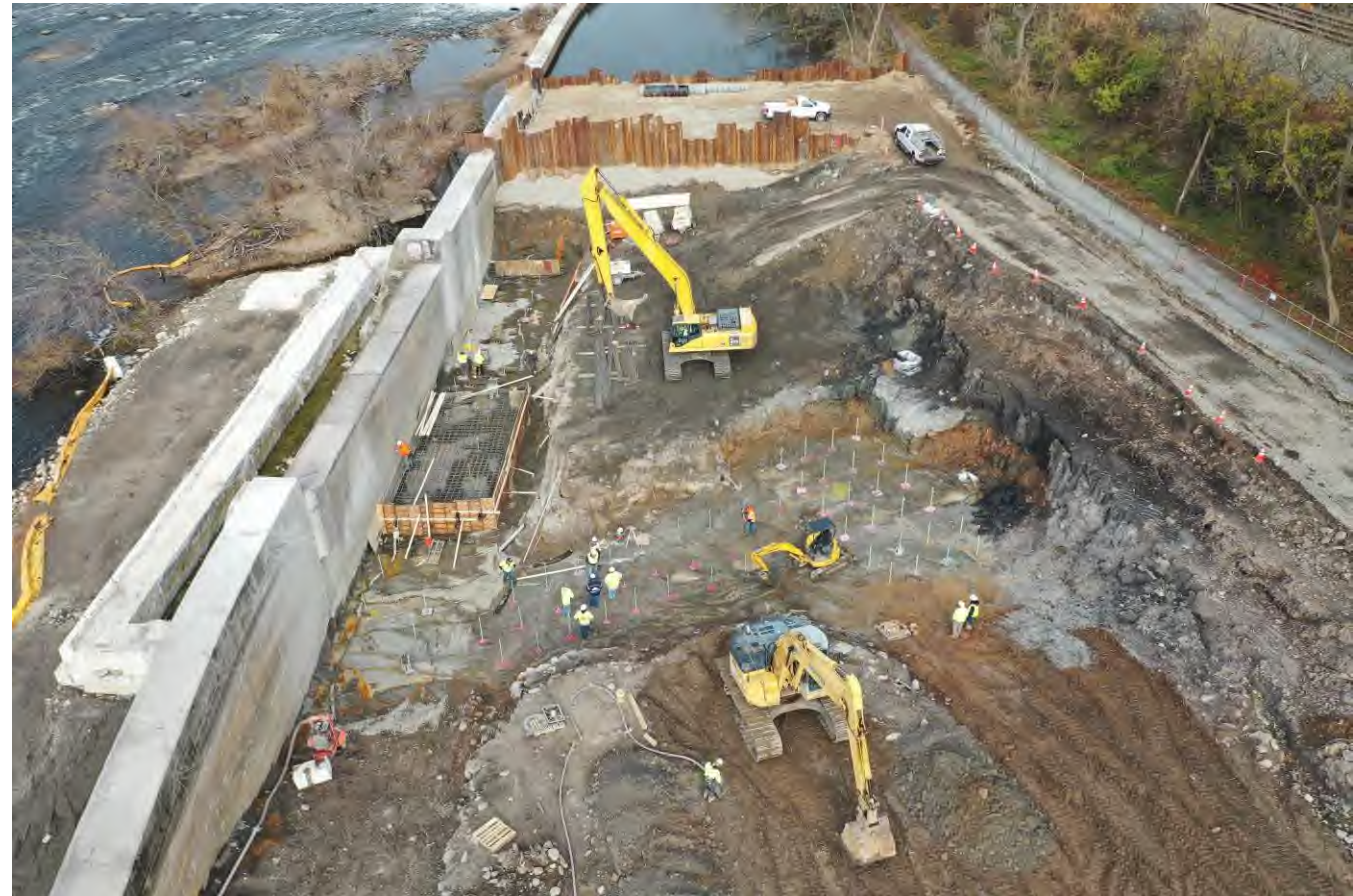
# November 2022 - First Concrete Pour for Weir foundation behind Existing Weir
