# Flat Rock Dam — Manayunk Canal Betterment Project

*Water Quality | Safety | Ecological Integrity*

**AWWA PA Section | Fall 2023 Joint Technical Conference**  
**Tuesday, October 24<sup>th</sup>, 2023 | 1:30 PM**

Construction Project Engineer for Flat Rock Dam

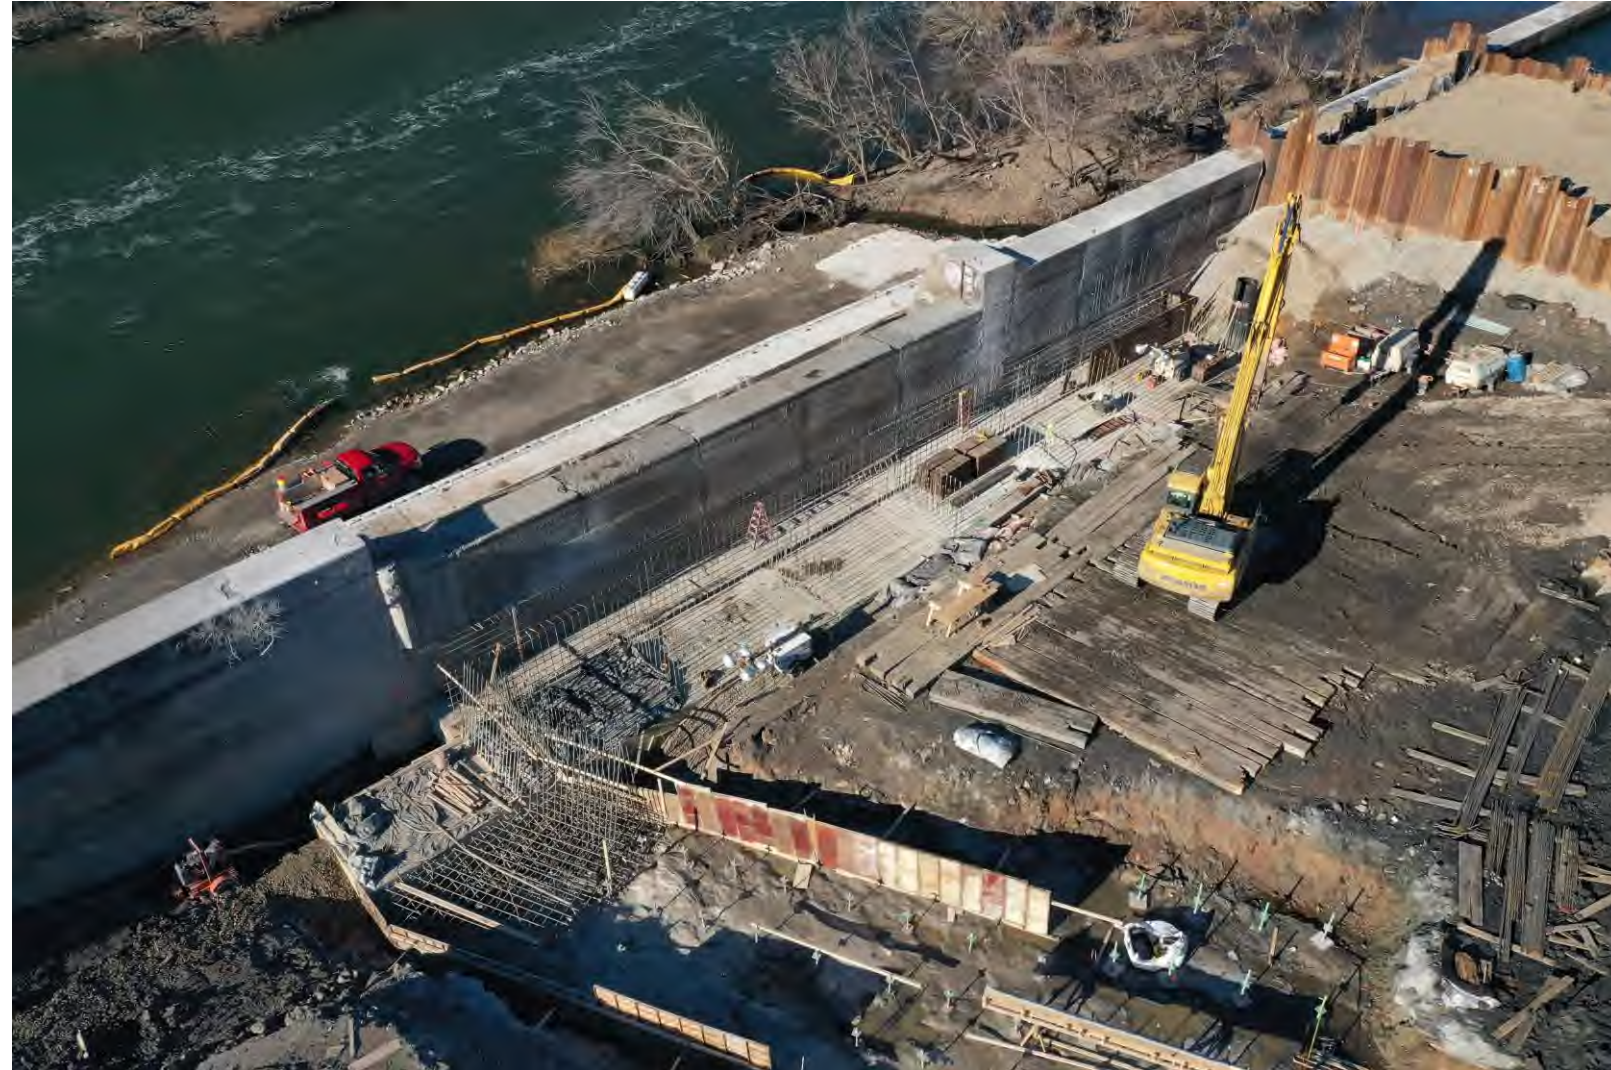
# December 2022

## - Constructing new concrete weir behind existing weir

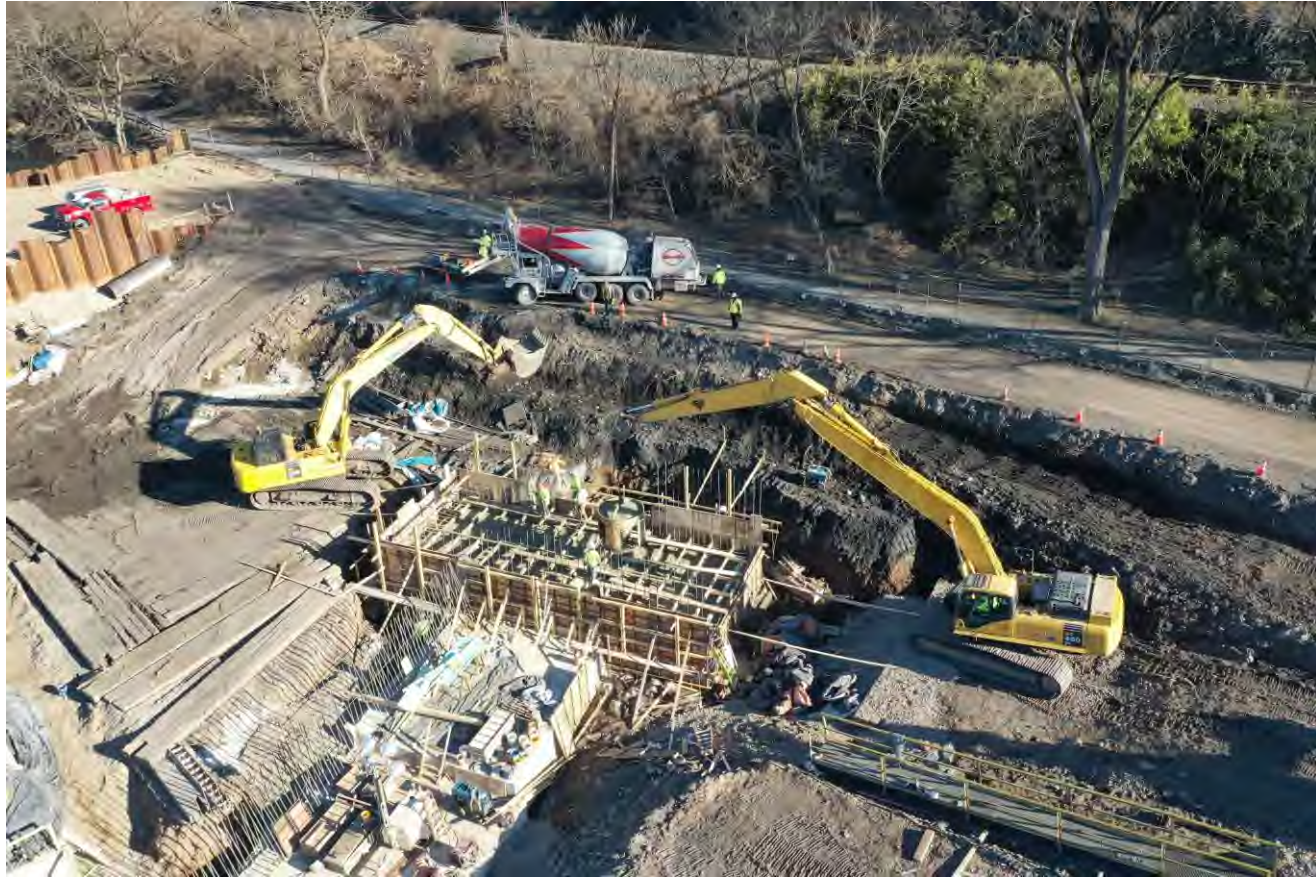
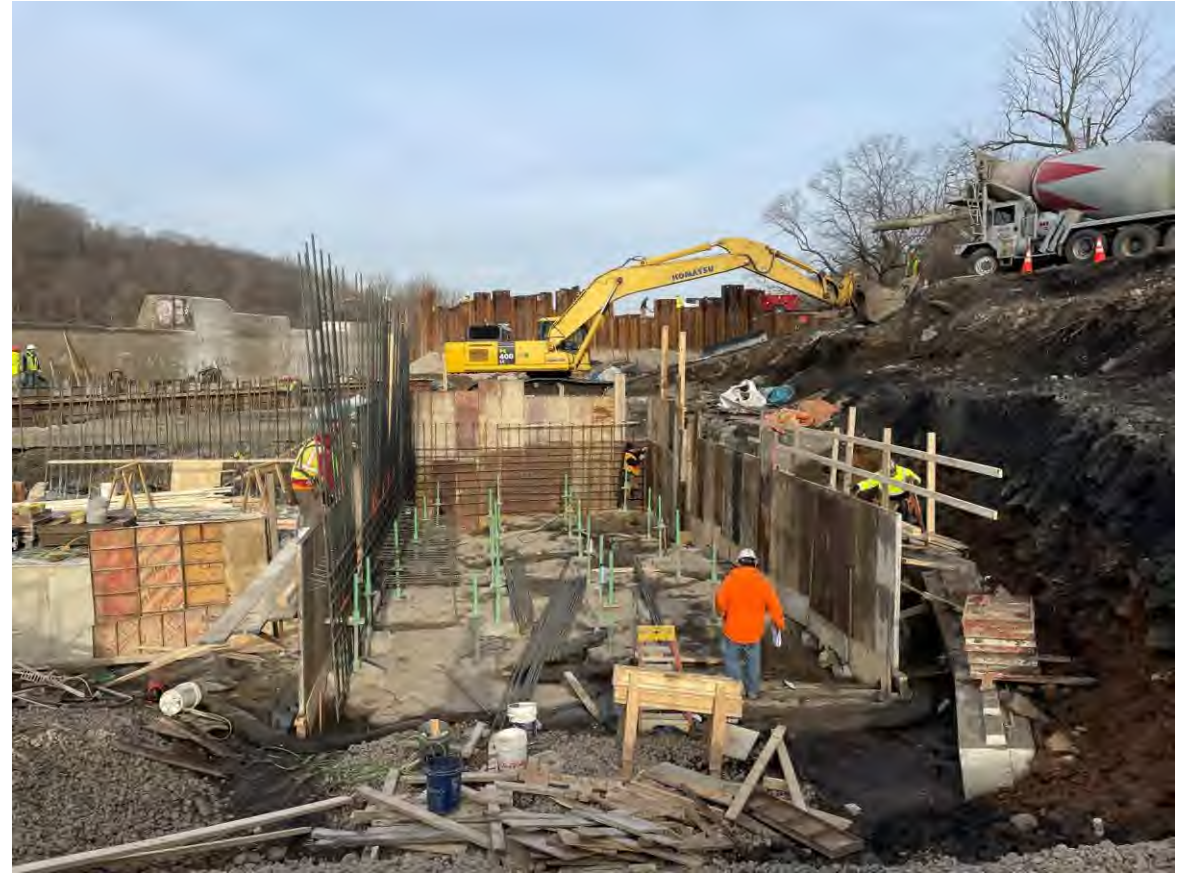
# February 2023 - Rebar, Formwork, and Concrete at Canal Intake Structure Foundation

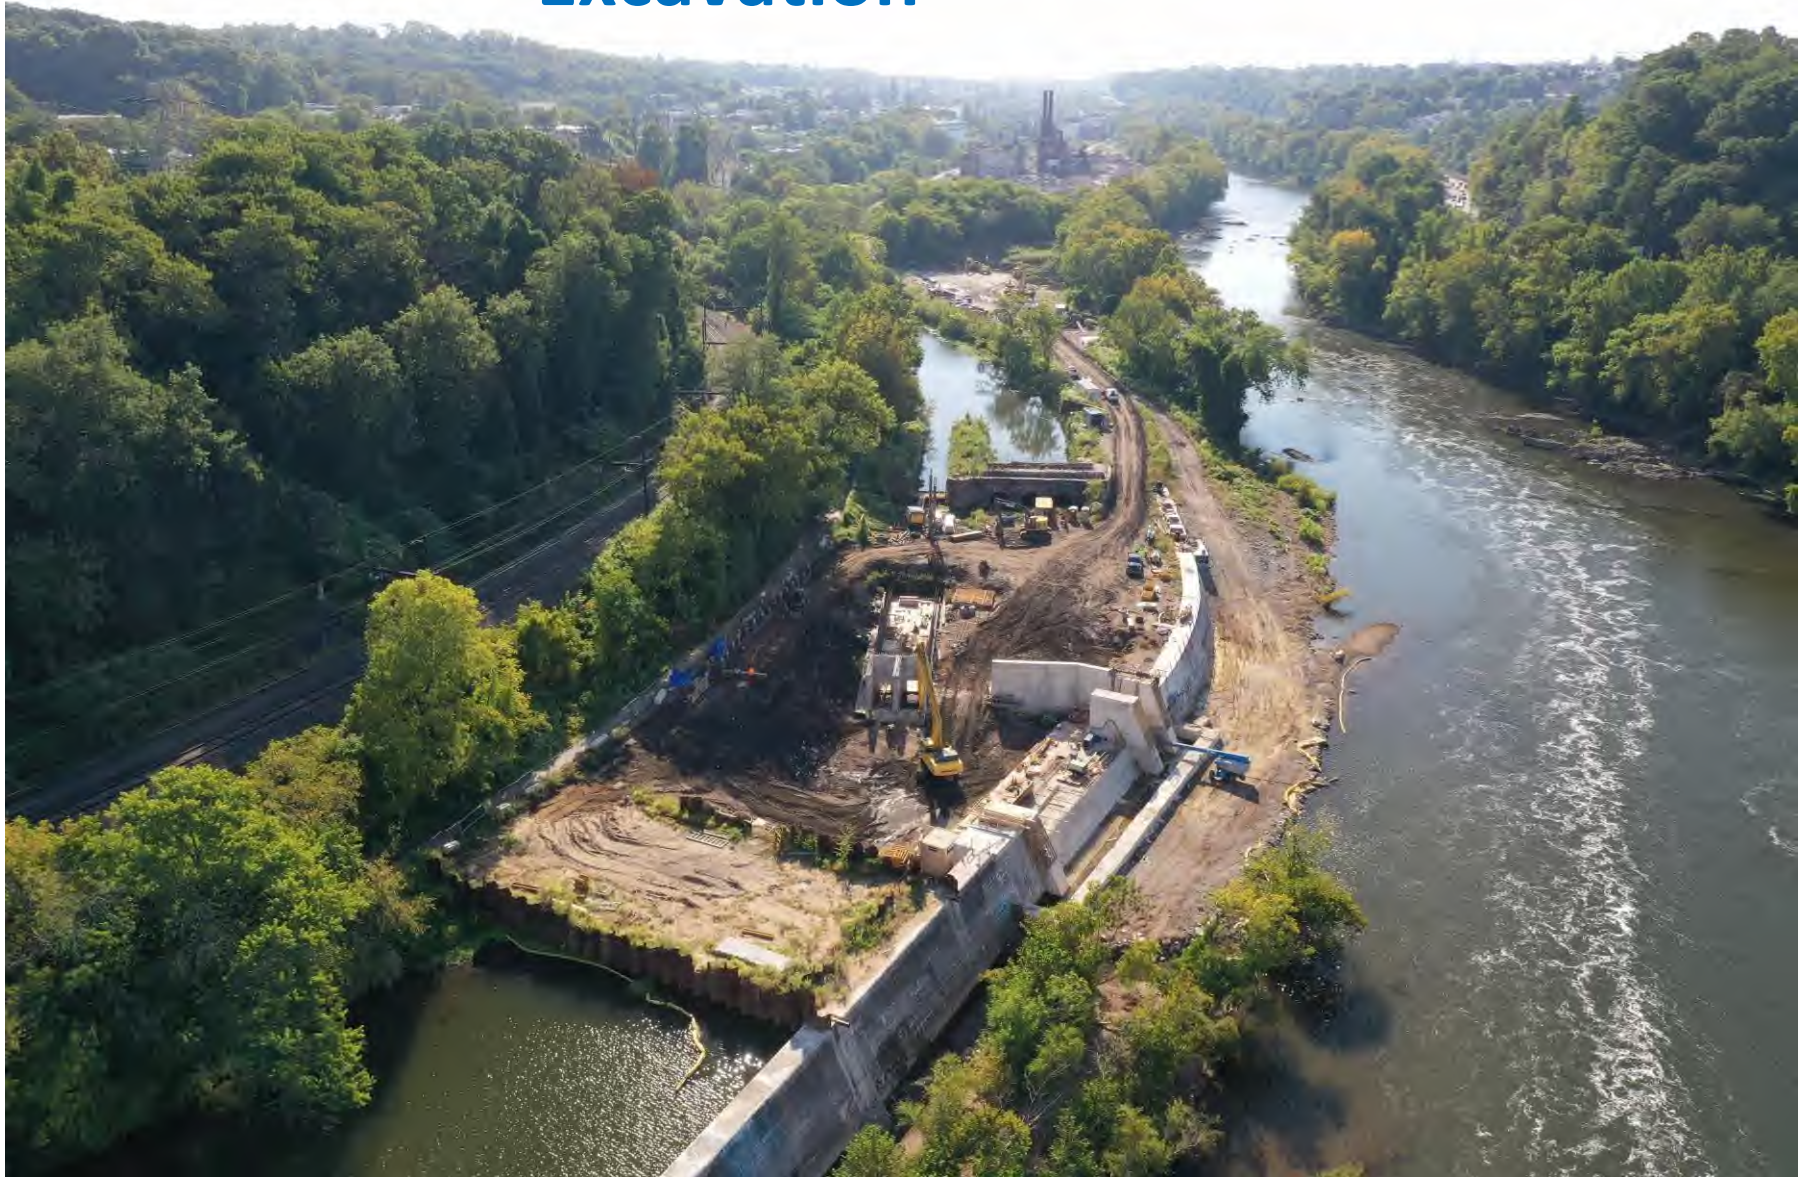
# September 2023 - Installation of Shoring for Bulkhead Wall Excavation

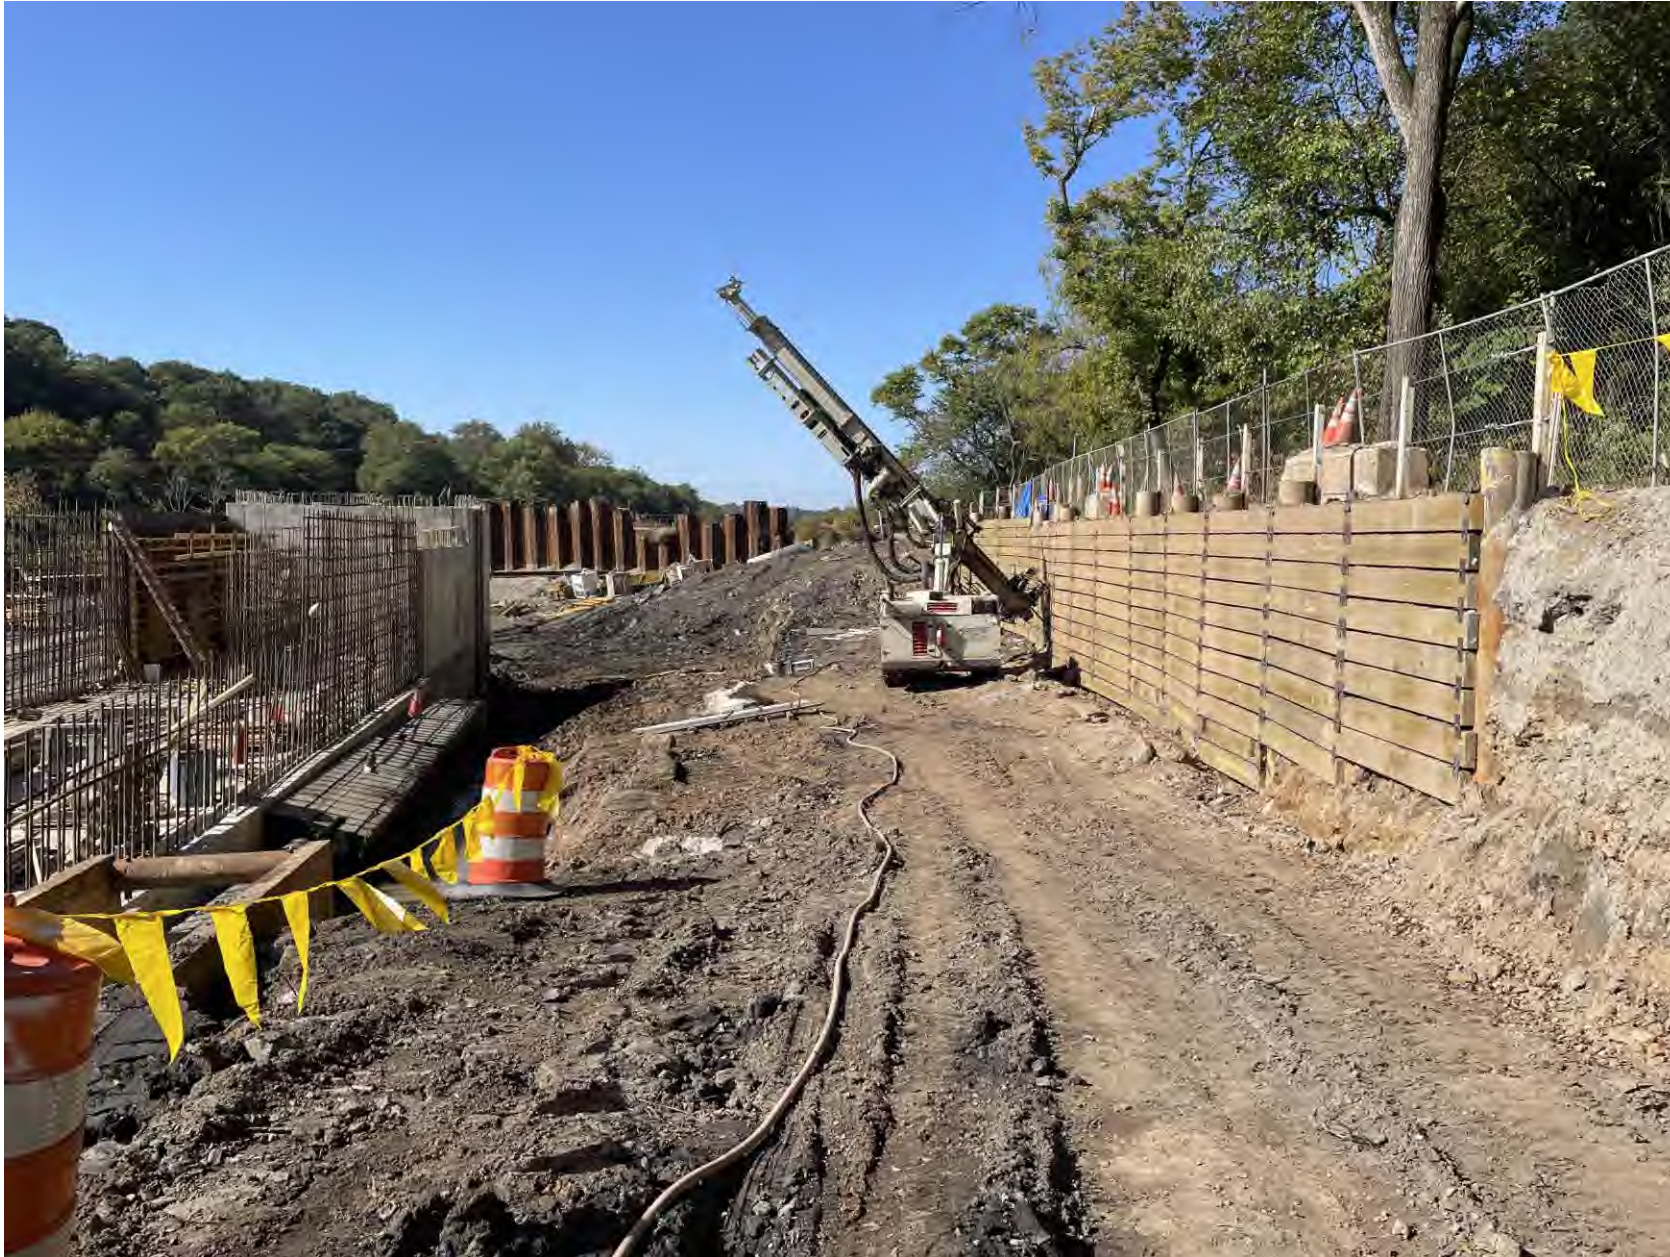
# October 2023 - Shoring and Tieback Anchor Installation

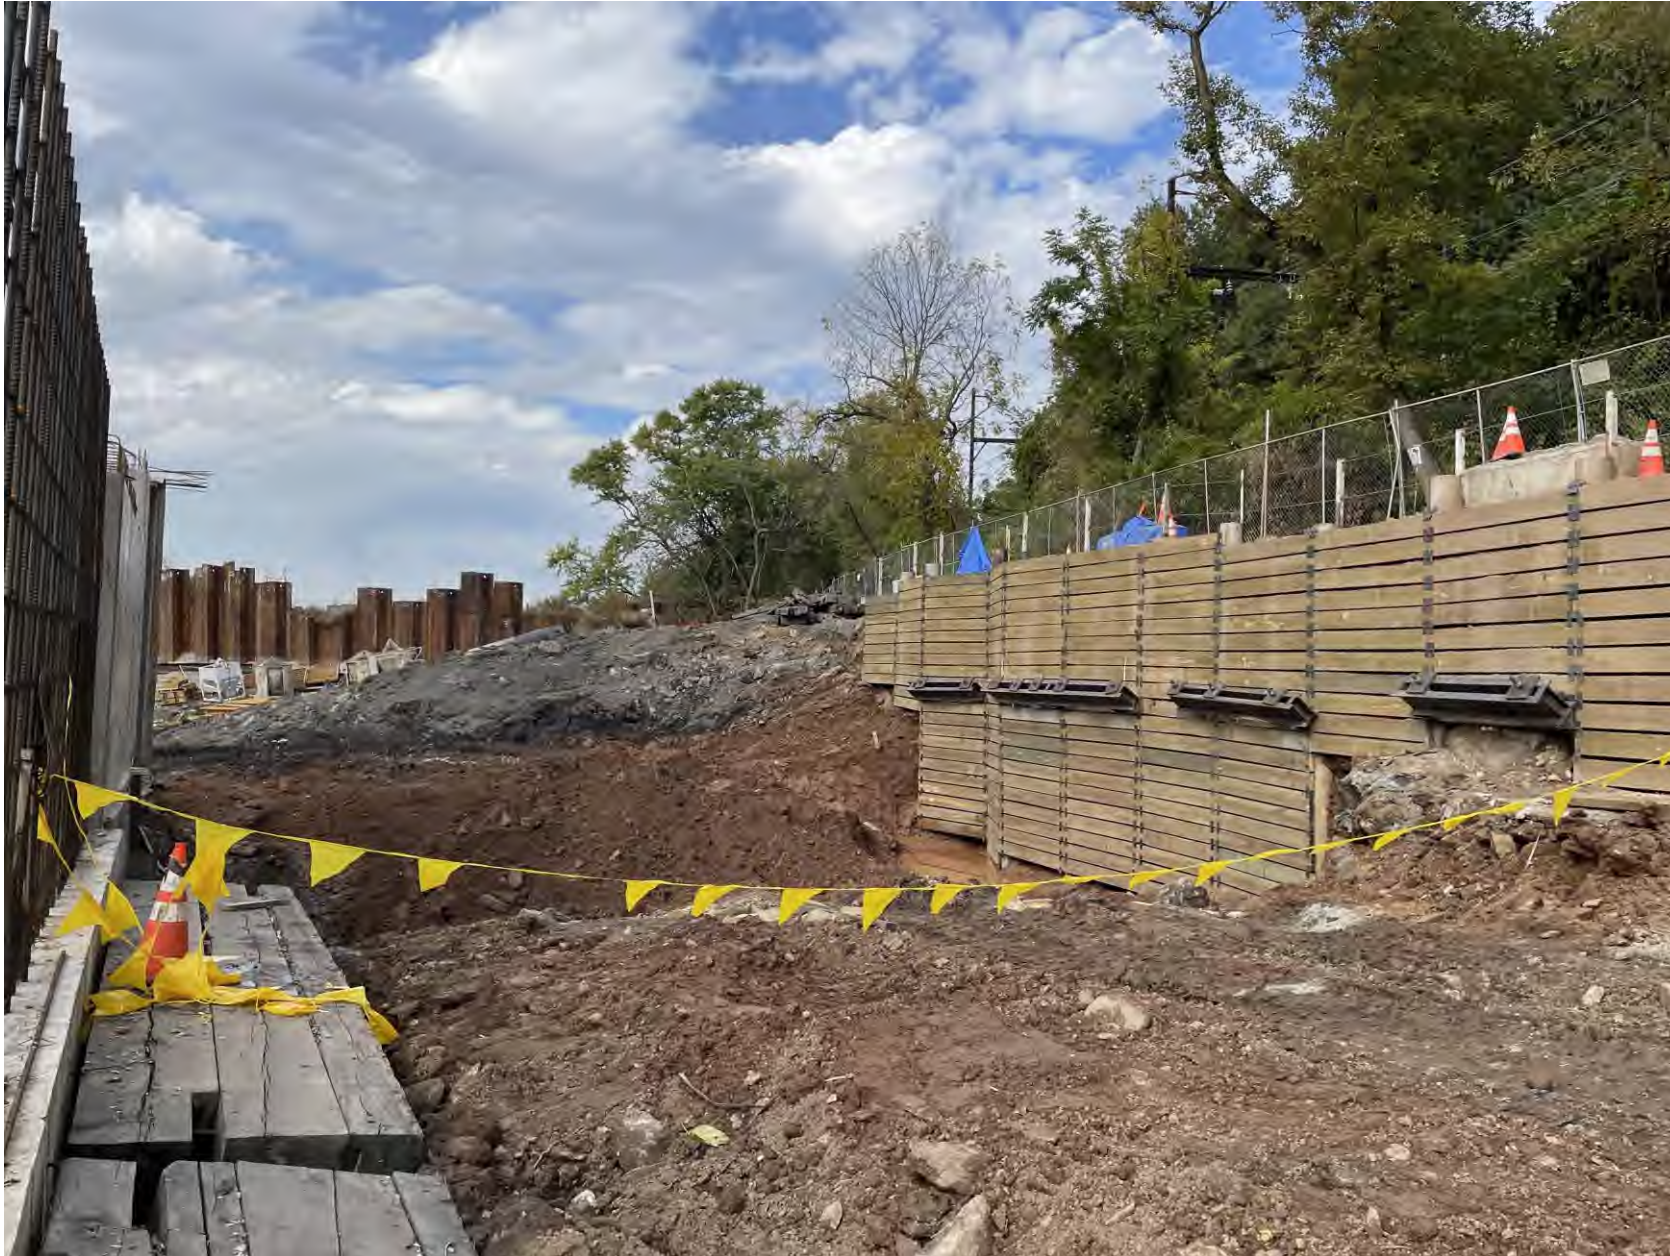
# October 2023 - Excavation, Shoring and Tieback Anchor Installation
